- Location:** Former Goodman Sparks site, Cliffefield Road, Sheffield
- Disciplines:** Demolition within a residential environment, close to houses and roads
- Client:** Duke Developments
- Programme:** 6 weeks

The former Goodman Sparks site, located on Cliffefield Road, Sheffield, was a former laundry and dry cleaner’s service. The company relocated elsewhere in Sheffield, and the Cliffefield Road premises had been derelict for some time.

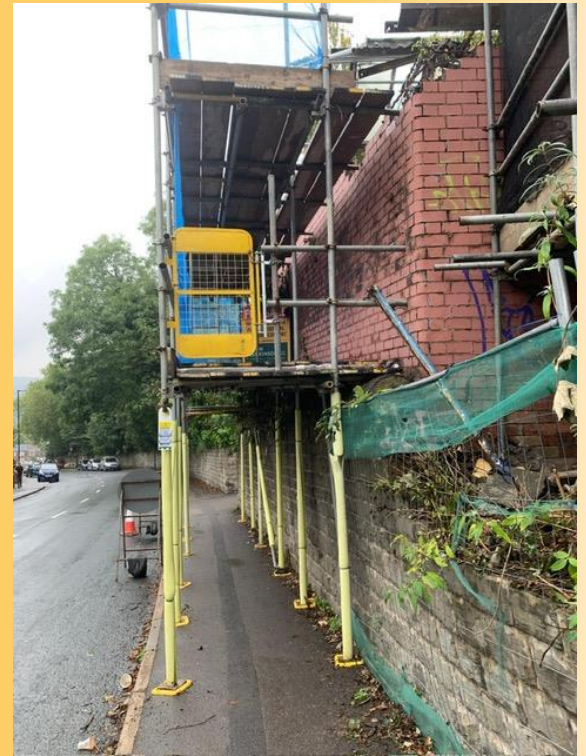
Pedestrian walk through scaffold at the Derbyshire Lane elevation

A pedestrian walk through scaffold, was set up to the Derbyshire Lane elevation, helping to maintain pedestrian access and avoiding any unnecessary pedestrian road crossings. The demolition at this area was carefully managed, with banksmen located roadside in assistance.

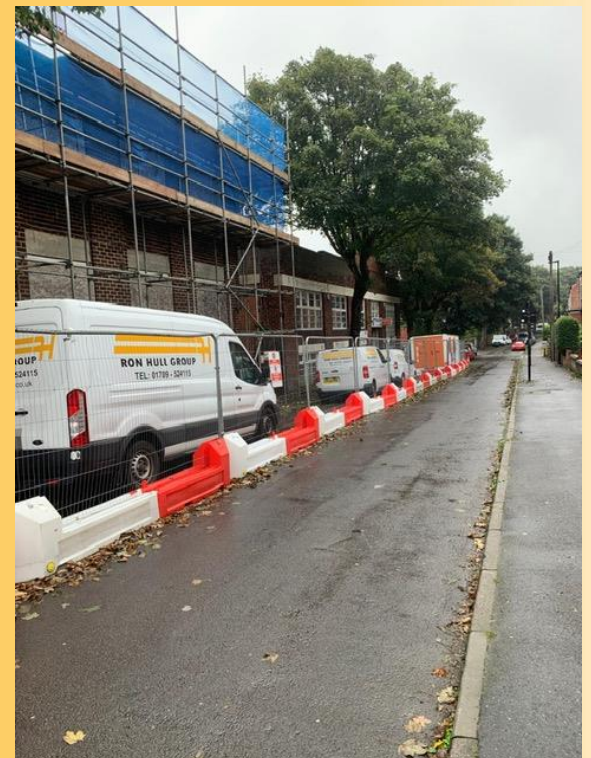
Footpath and half road closure in effect along Cliffe Road for full demolition duration

A full pavement closure and half road closure was in effect along Cliffefield Road throughout the demolition, with letter drops conducted to affected residential properties. It was decided that the best way to manage the traffic issues would be to close off access onto Cliffefield Road from Derbyshire Lane and instead create a one-way road.

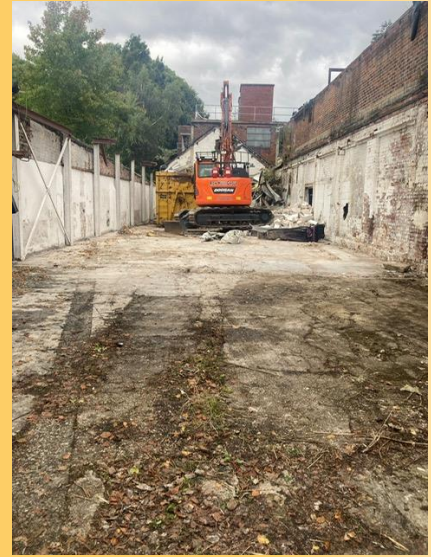
Demolition by 14t machine

The demolition was completed using our 14t and 25t machines, with bespoke shear and grab attachments following an agreed sequence through each building. Due to site space constraints, the 14t machine was initially needed to create room and working area for the 25t machine to operate.

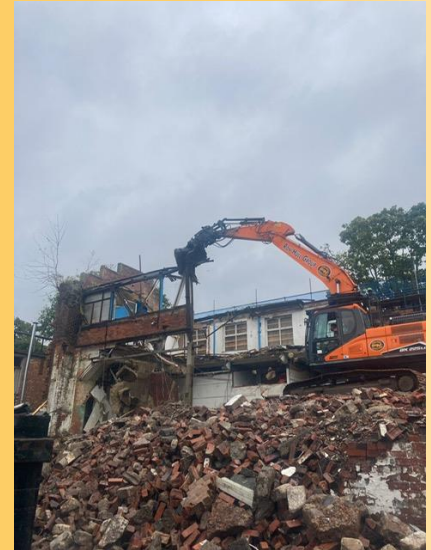
Demolition by 25t machine

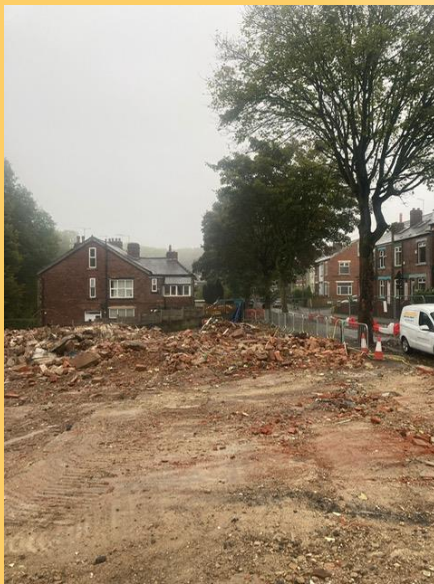
Removal of the waste following completion of the demolition work

The demolition waste was loaded into skips and lorries, before being removed off site, leaving the Client with a clean site, back to top of slab, for the next stage in the site's development.

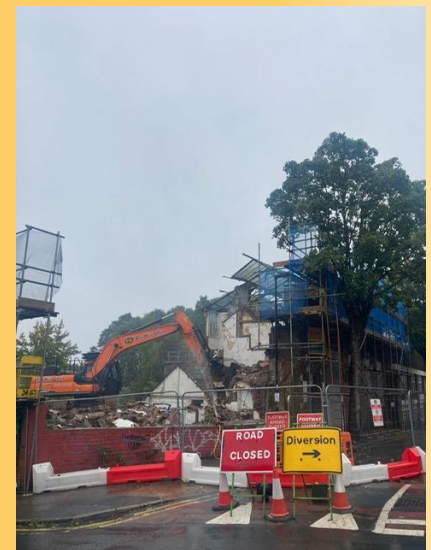
Road closure at Cliffefield Road
